## Development of a surface-specific, anti-weathering stone preservative treatment

Sudeep M. Rao<sup>1,2</sup>, Cathy S. Scotto<sup>3</sup>, C. Jeffrey Brinker<sup>1,4</sup>, Timothy J. Ross<sup>2</sup>

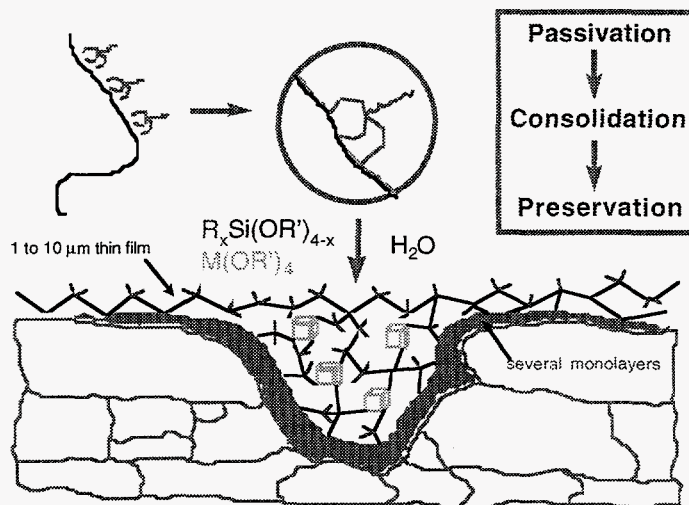
Figure 1. Schematic diagram of treatment for weathered limestone surface on a sculpted "nose". The gray area is the passivant that couples the limestone to the  $SiO_2$ -based consolidant above it. The  $R_x$  and M groups shown in the schematic can be tailored to increase the consolidant's hydrophobicity and strength respectively.

Our strategy to protect limestone is a surface-specific treatment that is designed to retard any further chemical or physical weathering by first rendering the limestone surface passive toward hydrolysis and second by strengthening or consolidating the already weathered structure (Rao [7,8], Cygan [9], Nagy [10]). A mineral-specific passivant molecule energetically binds to the calcite surface and also acts as a coupling agent for the consolidant (see Figure 1). The coupling is achieved by a polymerizable "tail" on the passivant that enables sol-gel condensation reactions with the consolidant. The consolidant offers strength to the weathered stone by forming an inorganic framework within the pore system. The sol-gel based consolidation process is amenable to the introduction of strengthening metal oxides and water repelling agents.

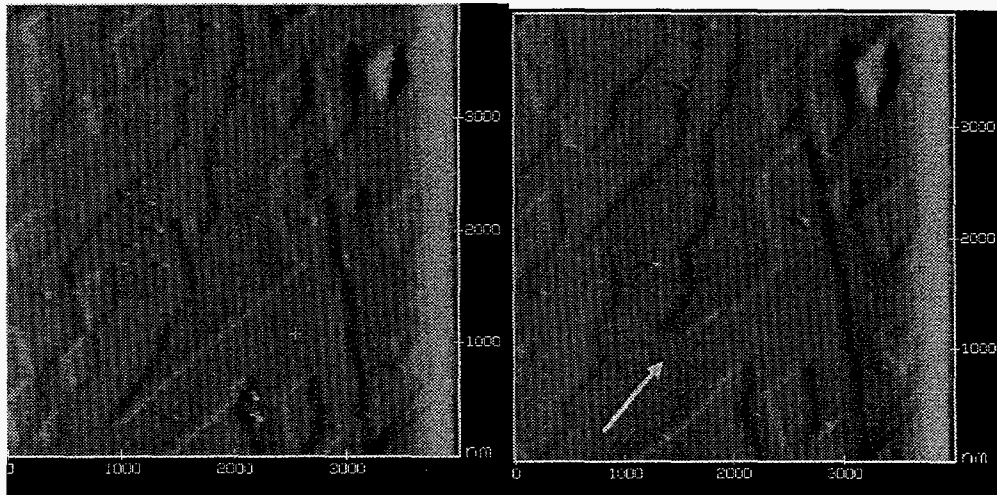
Figure 2a & b. SPM image (left) of single crystal calcite upon addition of simulated acid rain. The appearance of etch pits confirms rapid dissolution of calcite. The etch pits are diamond shaped ( $<1$  nm deep). Figure 2b shows the same location after 3 more minutes of exposure to the weathering solution. Note the enlargement of the etch pits and retreat of steps (esp. peninsular region in the center of the images).

Optically clear calcite samples from Chihuahua, Mexico were cleaved to expose the {104} surface. These were used directly to observe dissolution of calcite characterized by etch pit formation and step retreat on the surface, when exposed to corrosive solutions (see Figure 2). Samples to be treated were placed in the passivant solution for 30 min., rinsed with methanol and then placed in the consolidant for another 30 min. Following rinsing with ethanol they were dried in an oven at  $60^\circ C$ . We used a  $12 \mu m$  SPM piezoelectric scanner (Model-E) and  $Si_3N_4$  probes. The scan size was kept between  $4-10 \mu m^2$ , the Z-range at less than 25 nm, and the scanning rate was 4-8 Hz which results in an image-acquisition time of less than 90 seconds. To simulate acid rain weathering we used freshly deionized water ( $18 M\Omega$ ) which was allowed

Dissolution of untreated calcite was observed immediately upon addition of deionized water by the formation of etch pits approximately 200 nm along the diagonal and about 100 nm along the shorter diagonal (Figure 2a & b). The depth of the etch pits was about 0.5 nm which indicates that dissolution is occurring in monomolecular steps. The rate of surface loss was 4-7 nm<sup>2</sup>/sec. Further dissolution resulted in the retreat of steps and merging of adjoining pits (Figure 2b). This dissolution of calcite in the presence of an acidic undersaturated solution continues until equilibrium is reached in the fluid cell volume of the microscope. The etching of the surface re-commences after

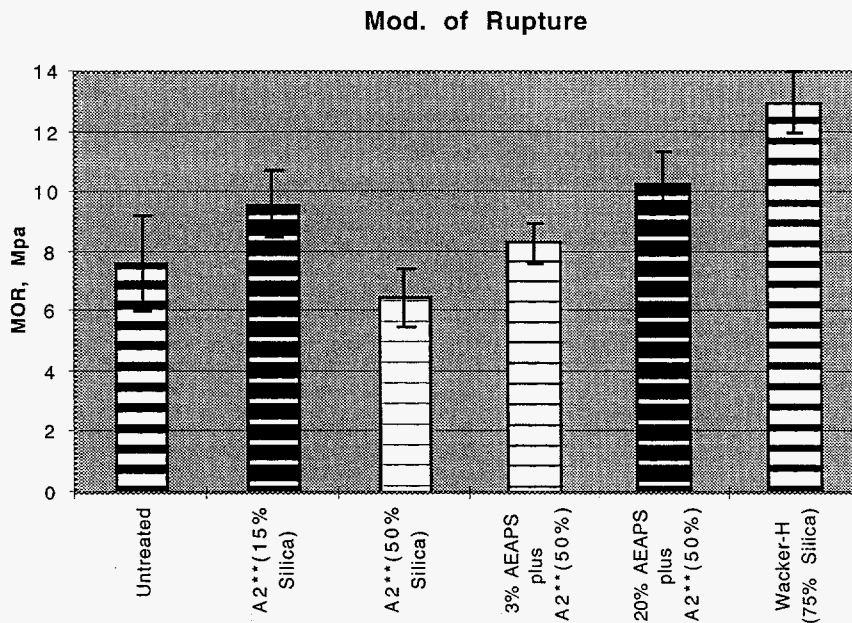
Figure 4. Plot of modulus of rupture for different treatments.

The effect of the different treatments on the modulus of rupture of the limestone cores as determined from the three-point bend tests is seen in Figure 4. Due to the heterogeneous nature of the stone, the standard deviations were large. The commercial consolidant Wacker-H with 75% silica gave the highest increase in flexural strength. The A2\*\* consolidant alone (without a passivant) with 15% silica, strengthened the stone compared with the more concentrated A2\*\* (50%). This counter-intuitive disparity is due to the processing conditions: the

A2\*\* 15% sol is subjected to two acid-catalyzed steps, aged and then diluted while the 50% A2\*\* sol is hydrolyzed by acid only once. The increased acid concentration and greater  $H_2O:Si$  ratio in the A2\*\* 15% sol enhance the hydrolysis rate (Brinker [15]).

This combined with the aging of the sol ultimately forms a stronger gel. The increase in the concentration of the AEAPS passivant from 3 to 20% results in a 25% increase in strength and a 35% increase compared to the untreated stone. Other researchers have also observed that the incorporation of AEAPS into silica aerogels showed reductions in gel times and increases in the bulk density (from reductions in surface area) (Husing [16]). The amino group may be helping to catalyze the condensation reaction due to its basic nature. Cores treated with the 20% AEAPS sol and the 15% A2\*\* sol were not tested due to the rapid gelation on the surface that prevents effective penetration and also leads to excess gelled material on the surface of the stone. The trisilanol form of the SAAC passivant was eliminated in preliminary experiments as it weakened the stone by binding too strongly to calcite and actually leached  $\text{Ca}^{2+}$  out of the samples.

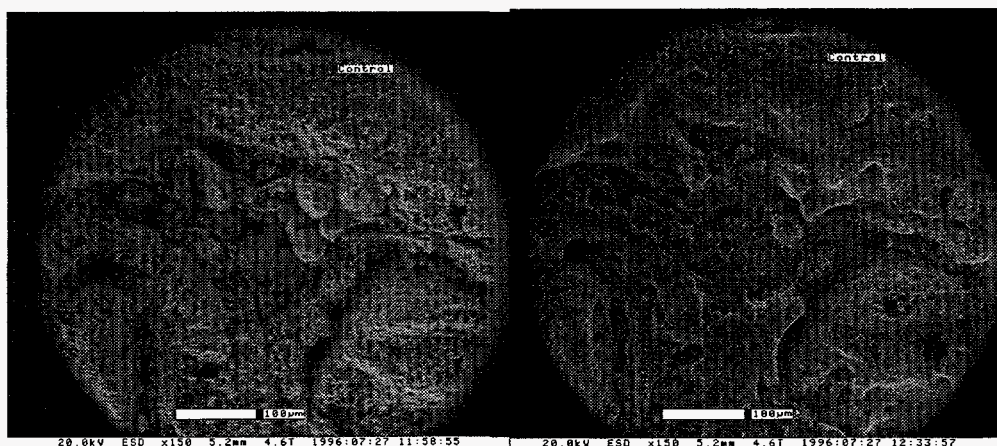
Figure 5a & b. Surface of untreated limestone shows ooids (concentric structures to the bottom left and right of Figure 5a) and polycrystalline regions (centre). Figure 5b shows the same region after addition of acid. Micron bar=100  $\mu\text{m}$ .

The untreated limestone is filled with ooids (concentric spherical structures) and consists of amorphous regions and polycrystalline phases of calcite (Figure 5a). Large voids amidst clusters of fine grained calcite in the limestone are seen. Figure 5b shows the same region after introduction of concentrated acid. Figure 6a shows limestone passivated with SAAC and consolidated with A2\*\*. the composite coating has cracked and retracted exposing bare calcite. Upon exposure to acid, the bare areas exhibit corrosive attack, but the coated areas do not, suggesting that the protective treatment, if continuous, would retard acid-rain attack. We believe that cracking results because the SAAC passivation layer does not bind effectively to the calcite surface, allowing the biaxial tensile stress developed upon curing to cause cracking and delamination (Chapters 7, 8 in Brinker [15]). Improved coupling chemistry combined with a reduction in the coating thickness should remedy this behavior.

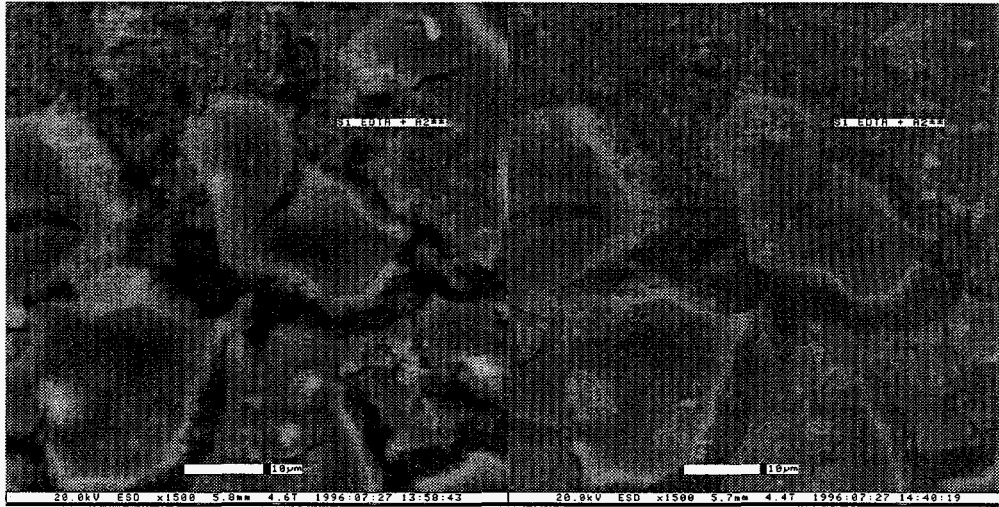
Figure 6a & b. Treated limestone before addition of concentrated sulfuric acid (Figure 6a). Inadequate coupling by the SAAC passivant led to shrinkage of the consolidant. Micron bar=10  $\mu$ m. Figure 6b shows the same region after addition of acid. The consolidated areas remain unaffected although the layer is cracked. Better coupling passivants and thinner consolidating layers can prevent the cracking.
